SUBJECT: Architectural Design Services-AHS Administration Offices

ADDENDUM NO. 1

HVAC Upgrades
and Office Reorganization Study

Arlington School District Offices
Arlington, MA
Existing Conditions Systems Report
J#525 010 00 00
L#37027/Page 1/March 16, 2012

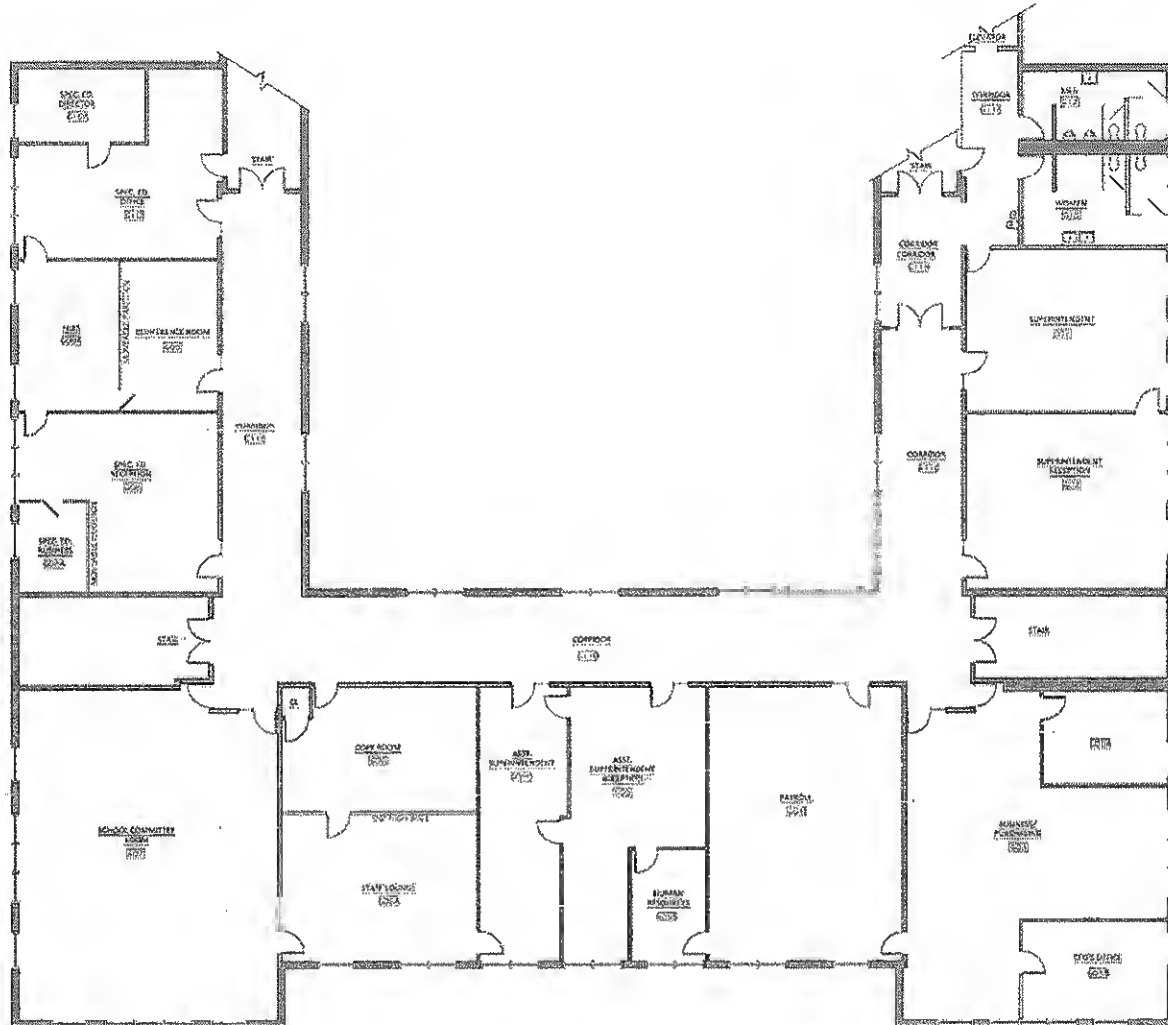
1 6TH FLOOR PLAN, EXISTING
1/4" = 1'-0"

Existing Floor Plan: 14,006 GSF

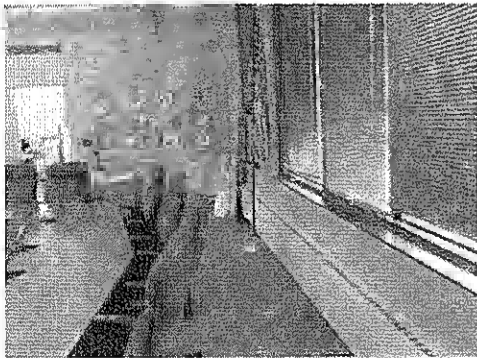
The majority of fin tube radiation appears to be in good to fair condition. In general the radiation enclosures appear to have finishes in good condition, however some segments are damaged and should be repaired.

Example of Fin Tube Radiation Heating

Priority 1 – In order to minimize project cost is recommended that the existing hot water perimeter radiation heating system is re-used as part of the renovation project. Ideally fin tube radiation should be modified in some office areas that have previously been sub-divided or will be sub divided as part of the planned renovation. This modification would involve installing additional zone control valves and hot water branch piping and valves in order to create additional zones.

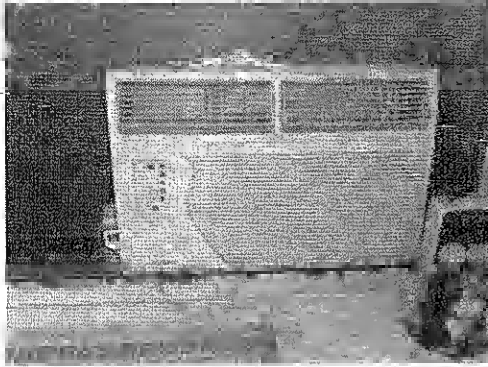
Air Conditioning is provided to the majority of offices by window type air conditioning units. The majority of window AC units appear to be of an older variety and have low energy efficiency in comparison to high efficiency systems that are commercially available. In addition window AC units are noisy during operation.

Typical Window AC units

Air Conditioning System – It is recommended that the existing window air conditioning units be replaced with a new high efficiency air conditioning system.

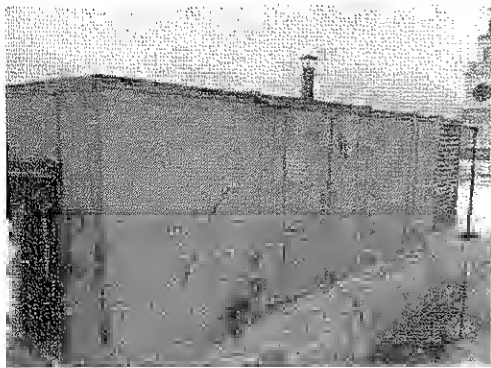
The building is primarily ventilated through the use of rooftop air handling unit. The rooftop unit was installed in the 1970s and the unit and associated roof mounted ductwork are in poor condition. The unit was manufactured by Jackson Church Co. The unit was originally designed and installed to provide ventilation for classrooms; therefore the existing unit has a higher airflow capacity than required for the current office occupancy. Due to the unit being oversized, there are many temperature control complaints related to the operation of this unit. To address this issue, the building operator staff has had to turn this unit on and off during select periods of the day. The majority of the ventilation air ductwork mains are located in the main corridor. Branch ductwork is typically routed from the mains to the offices, and typically terminates in a sidewall register. The ventilation system was not modified when new office partitions were added; therefore ventilation air is not currently ducted to each individual office.

Existing rooftop Air Handling Unit

Ventilation System – It is recommended that a new rooftop unit is installed to replace the existing rooftop heating and ventilation unit. The new rooftop should be provided with supply fan equipped with variable speed drive, steam hot water heating coil, and packaged DDC controls capable of being integrated into the Building Energy Management system.

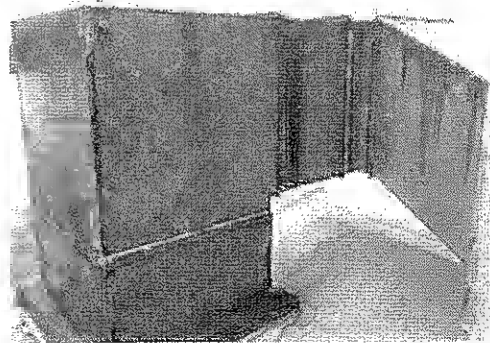
Existing roof ventilation ductwork

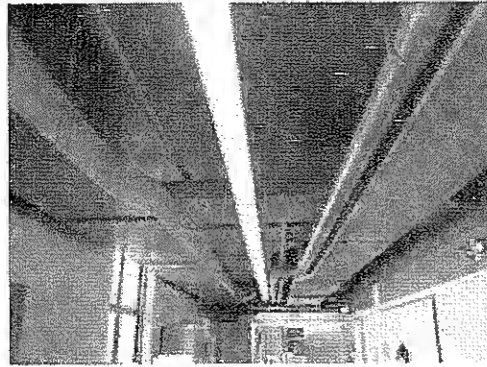
Corridor – Ventilation Ductwork

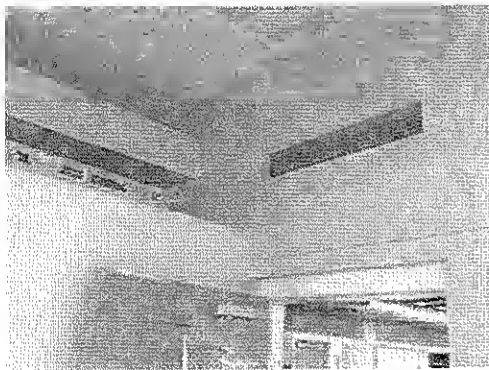
Ventilation Register in Office (typ.)

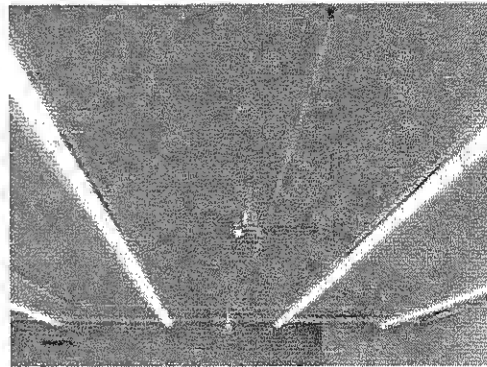
Ceiling Fan in Office

Some offices have ceiling mounted de-stratification paddle fans installed.

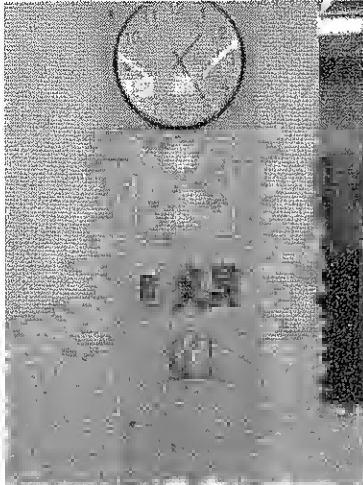
Thermostat (left, typ.)

Priority 2: It is recommended that the existing pneumatic control valves are replace with new DDC control type thermostats which are controlled by a new DDC control panel. The new DDC control panel would be integrated into the existing Building energy management system

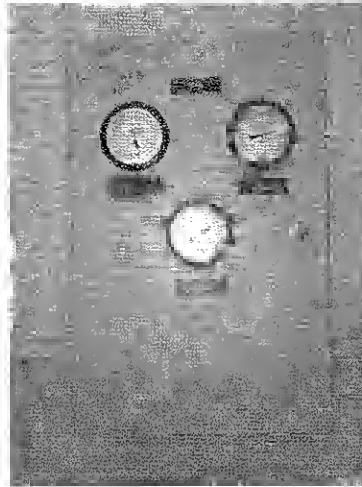
Hot Water Pump Control Panel

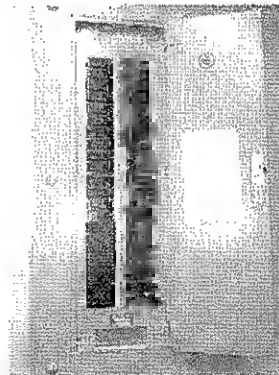
An air conditioner panelboard was added during the office renovation phase approximately 10-15 years ago, rated at 225 amperes, 42x, with (15) 20 ampere, 2 pole and 30 ampere, 2 pole breakers. This panel is located on the Sixth Floor and is fed from the 3,000 ampere switchboard with a 225 ampere feeder. The panel feeds (15) window A/C units on the Sixth Floor.

A/C Panel

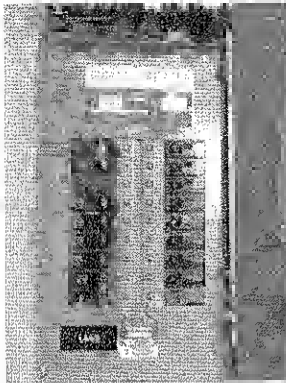
The Sixth Floor is serviced by two originally installed panelboards, flushmounted in the Corridor. LA6A and LA6B each rated at 225 amperes. Panel LA6A has 30 poles and is fed through the Fifth Floor panel LA5A and both share a single 225 ampere feeder. Panel LA6A services both power and lighting for the Sixth Floor West side. Panel LA6B has 18 poles, and likewise, is fed through the Fifth Floor panel LA5B and both share a single 225 ampere feeder. Panel LA6B services both power and lighting for the Sixth Floor East side.

The LA6A and LA6B panels are in fair condition but are over 30 years old and are full. The panels should be replaced on a one for one basis with a 42 pole panel to allow for additional circuitry or new subpanels provided. New panels would reconnect to the existing feeder.

Panel LA6A

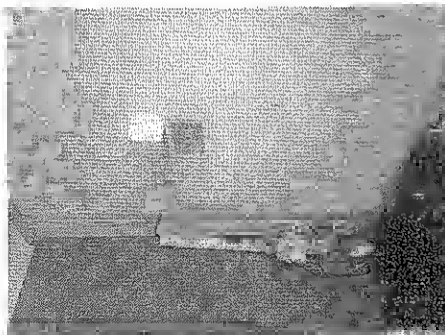
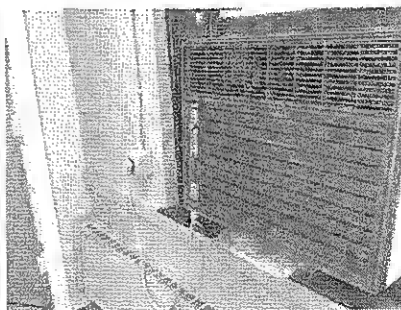
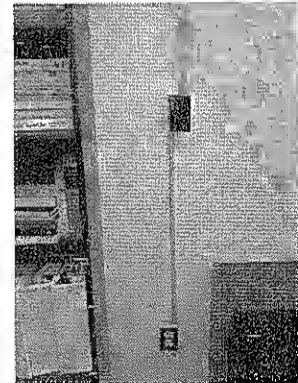
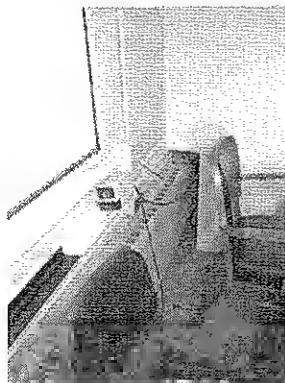
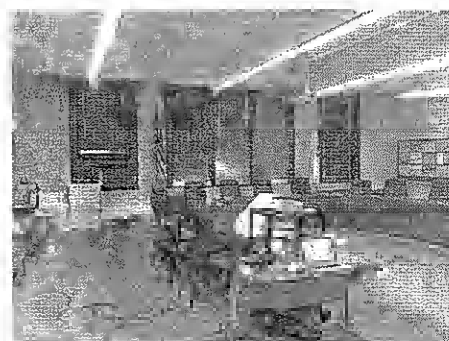
Dedicated branch circuits were added for the window A/C units. Wiring in general runs in surface EMT and surface boxes. Exposed Tel/Data wiring is also common.

Devices appear to be lacking in various work spaces, extension cords are being used.

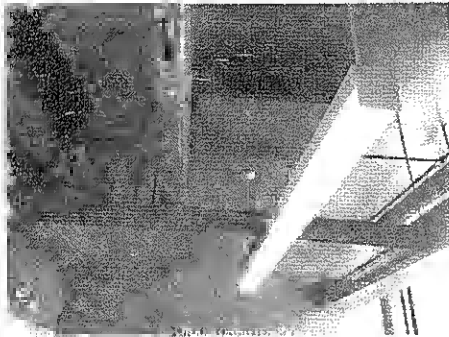
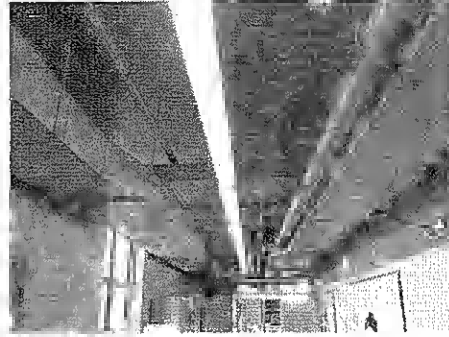
Corridor lighting consists of suspended linear fluorescent fixtures with baffles with single T8 lamps and electronic ballasts. Corridor lighting is locally switched. In general, lighting has been upgraded to T8 lamps and electronic ballasts.

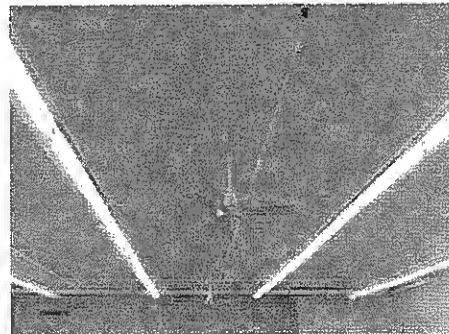
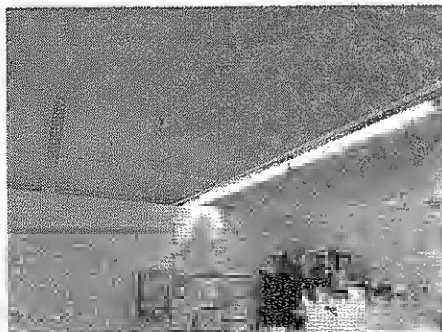
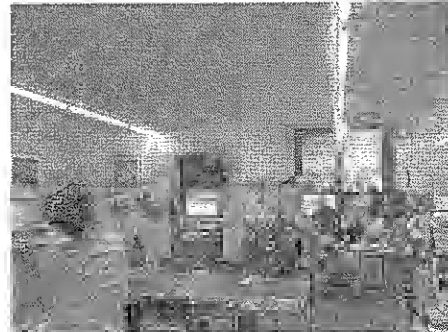
Former classroom spaces have suspended linear fluorescent fixtures with specular reflectors with single T8 lamps and electronic ballasts. Spaces are multi-switched by row.

Switching still occurs based on original layout rather than by individual spaces in various locations. Continuous light fixture rows are common to more than one working space.

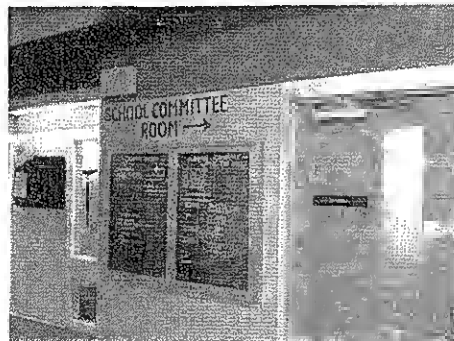
The emergency lighting system consists of central battery units with remote heads with PAR 38 lamps.

Exit signs exist with AC/DC sockets where they normally run on normal A/C power and are lit with the DC sockets via the central battery unit upon normal power loss.

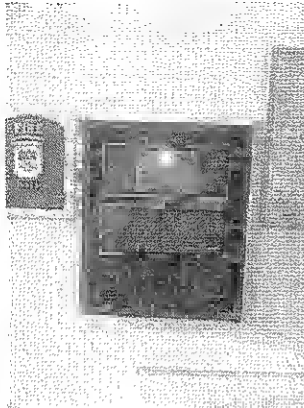
The overall facility is serviced by three separate fire alarm control panels connected to three radio boxes. The building "A" is serviced by a recently installed Notifier addressable control panel located in the Third Floor. The FACP is connected to a radio box to transmit alarm signals to the Fire Department.

The horn/strobes are not ADA compliant. Manual pull stations exist at the entrance to the stairwells. Existing devices should be replaced with new addressable devices and ADA compliant horn/strobes in Sixth Floor and connect to new control panel.

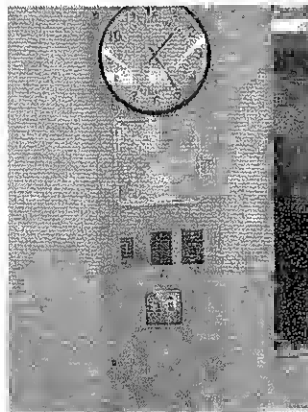
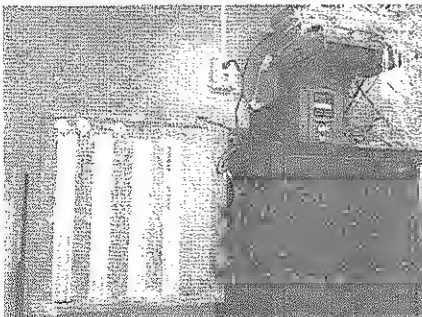
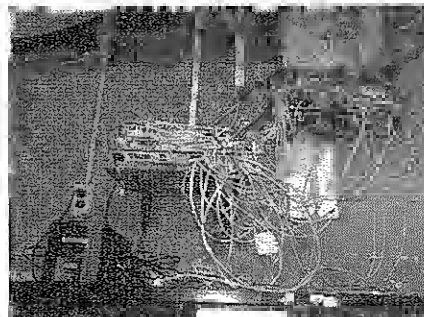
The original clock and speaker system still exists in JC panels by the classroom entrance. Corridor flush speakers exist.

The Tel/Data wiring is CAT5 terminated on wall mounted patch panels. Data switches are connected with fiber. A portable UPS exists for backup power.

Long patch cords are being used due to location of data outlets being distanced from work stations.

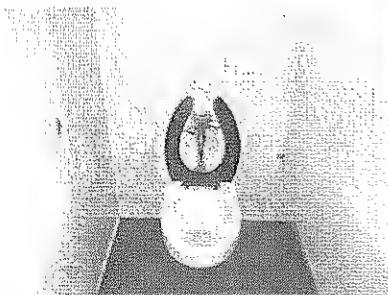
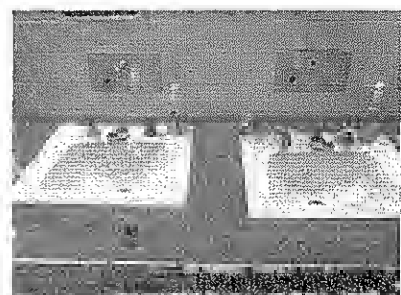
The plumbing fixtures are in good condition. Attempts have been made to make some bathroom fixtures accessible, however, the majority of fixtures do not meet current accessibility codes. In general, the fixtures appear to have served their useful life. Current Access Code requires accessible fixtures wherever plumbing is provided. In terms of the water conservation fixtures, their use is governed by the provisions of the Plumbing and Building Code. Essentially, the code does not require these fixtures to be upgraded, but where new fixtures are installed, as may be required by other codes or concerns, the new fixtures need to be water conserving type fixtures.

Urinals are wall hung vitreous china with manually operated flush valves.

Lavatories are wall hung vitreous china. Lavatories are fitted with hot and cold water handle faucets.

Typical bathroom fixtures

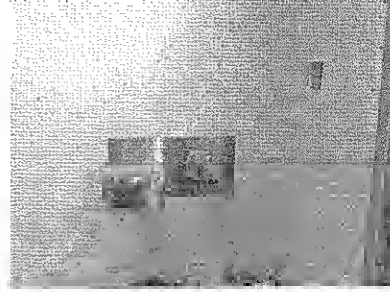
Staff sink is stainless steel counter top mounted with single handle faucet with a vegetable spray.

Drinking fountain is wall mounted, stainless steel, hi-lo fixture.
